# Manhole Inspection Summary

Manhole # S17CC1018MH

**Location** Address: **2274 PARK HILL AVE**

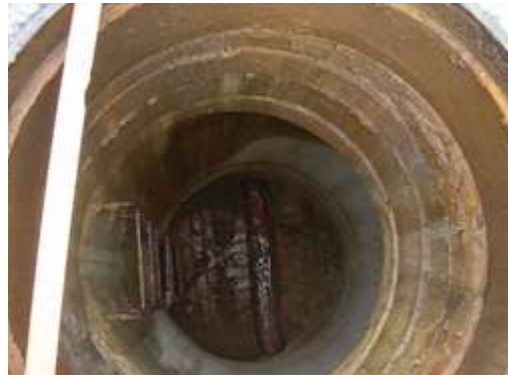
Top View

Corroded steps. Bench and Channel debris.

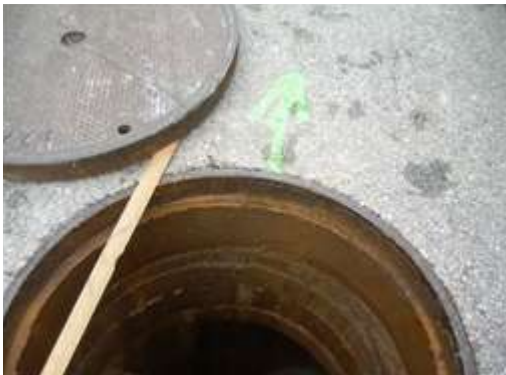
Defect

Frame leaks. Adjustment infiltration.

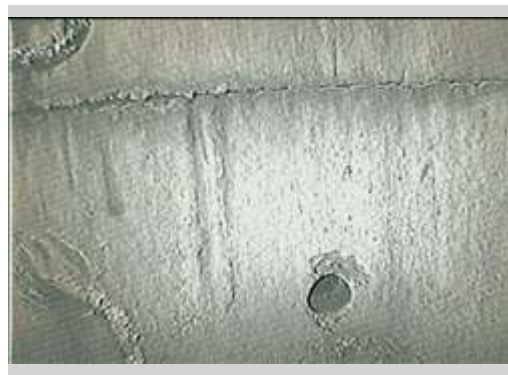
Defect

Barrel infiltration.

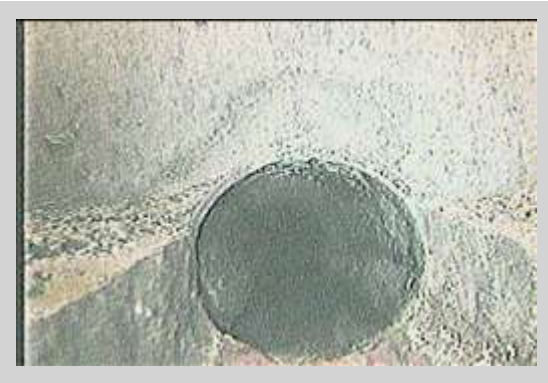
### 8 in. Circular Gravity Sewer Pipe Out @ 12 O'Clock

Pipe Material: **DIP/CI** ☐ Pipe Lined

Invert Depth: **10.79** (ft.) Flow Characteristics: **Slow**

Infiltration: **None** Pipe Seal Cond: **Unknown**

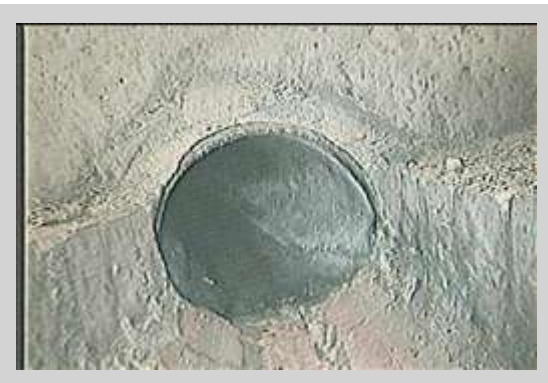
### 8 in. Circular Gravity Sewer Pipe In @ 6 O'Clock

Pipe Material: **DIP/CI** ☐ Pipe Lined

Invert Depth: **10.77** (ft.) Flow Characteristics: **Slow**

Infiltration: **None** Pipe Seal Cond: **Unknown**
